Subtrochanteric Fractures

Dr. (Prof.) Anil Arora

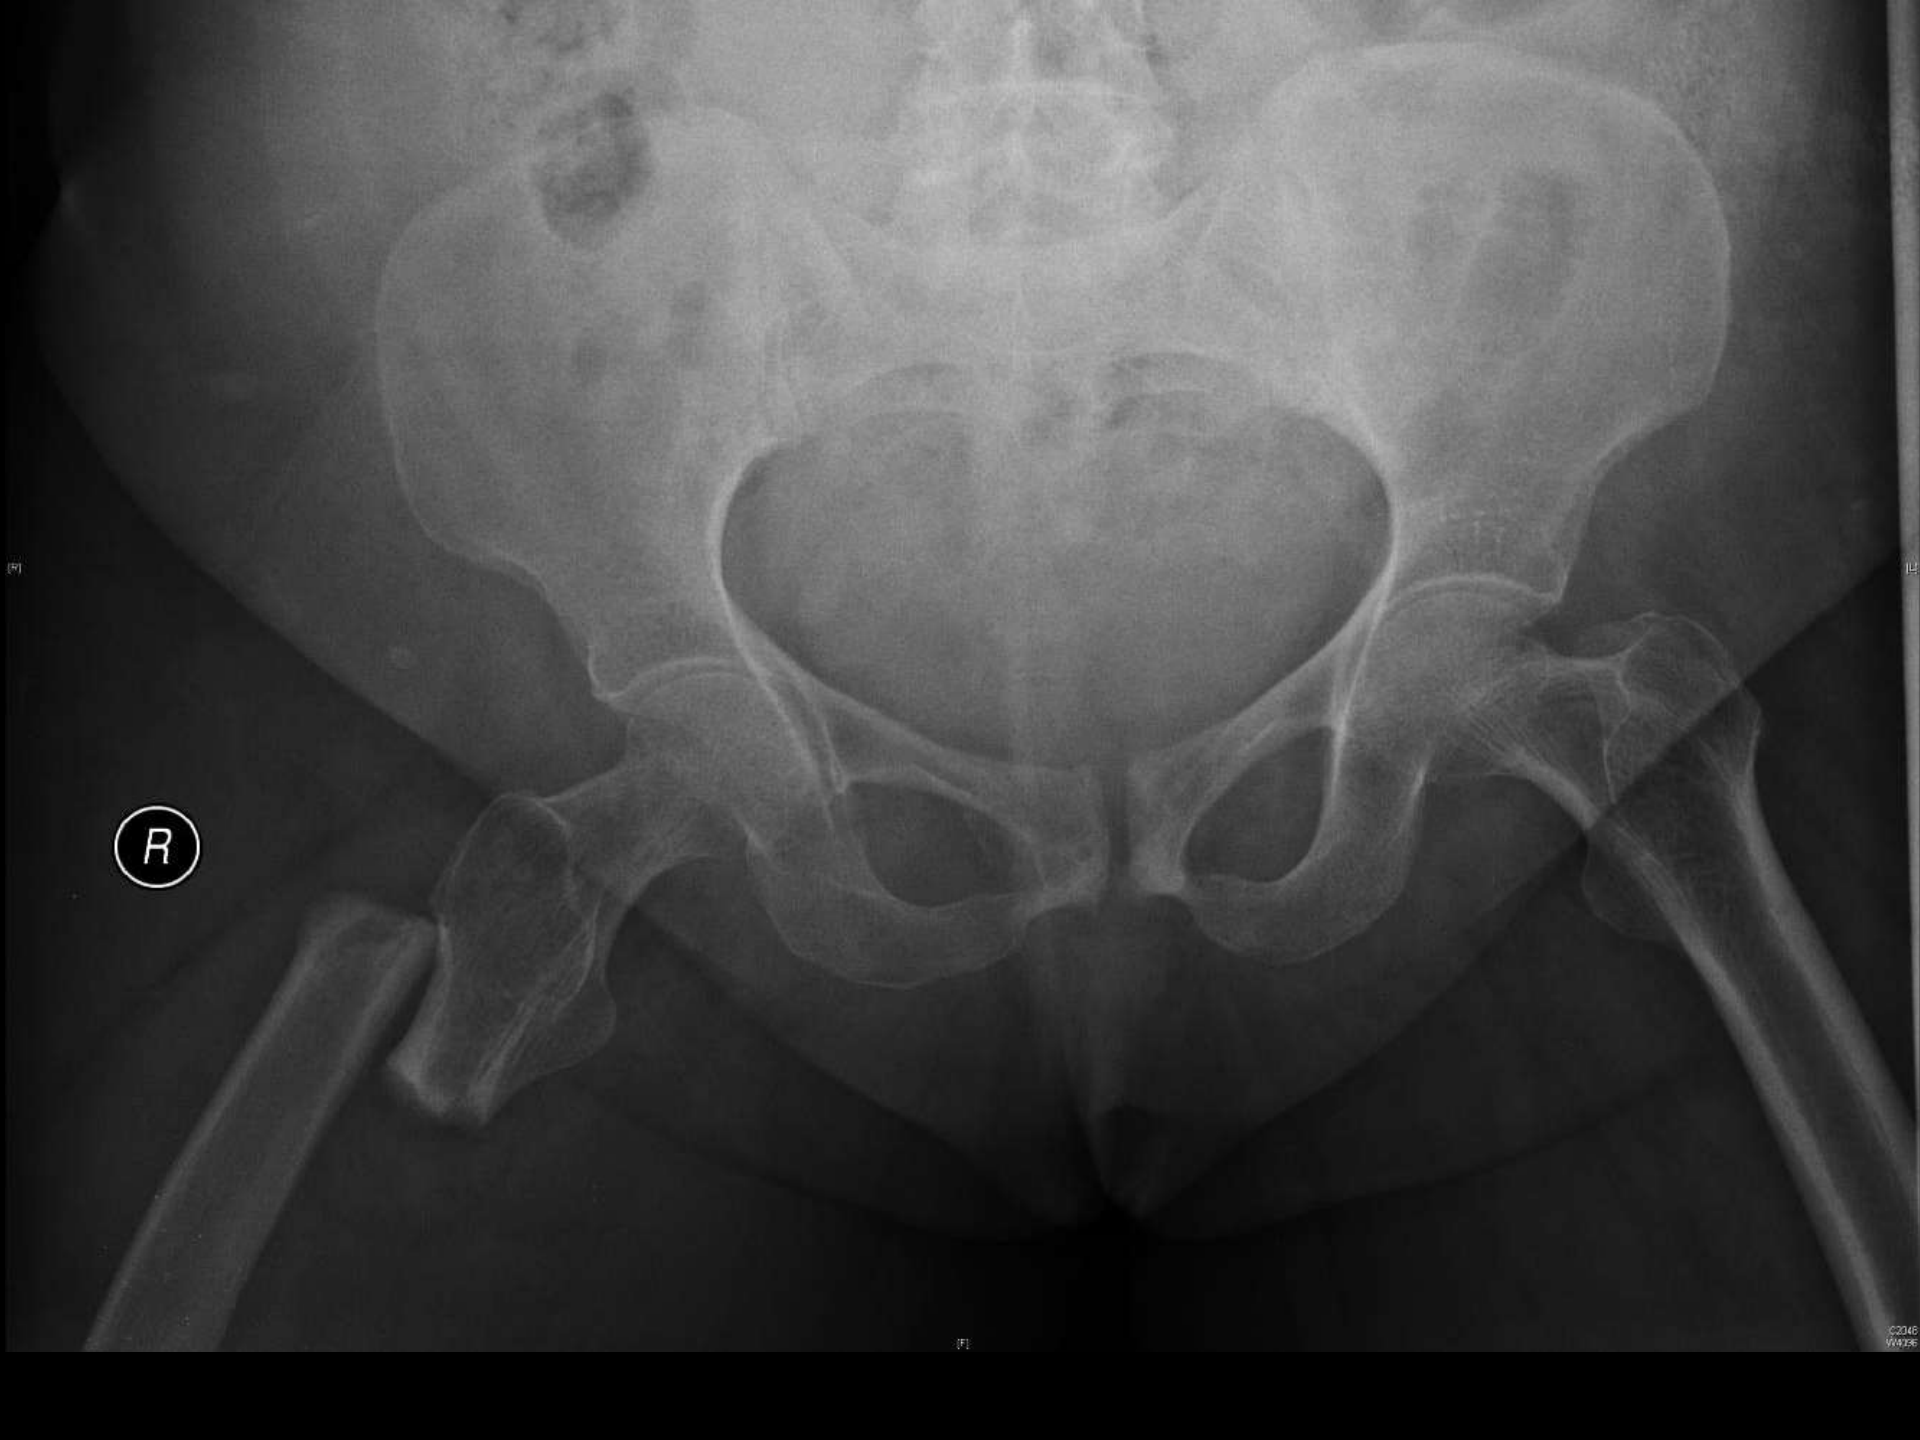
R67

This is an anteroposterior (AP) radiograph of the pelvis and upper femurs. The image shows the bony structures of the pelvic girdle, including the iliac, ischial, and pubic bones, as well as the proximal femora. The central pelvic cavity is visible, and the sacrum is partially seen at the top. The label 'R67' is positioned on the left side of the image, which corresponds to the patient's right side. The overall image is in grayscale, typical of a standard X-ray.
